Report: 0000814 **Address:** 4567 NE 78th Ave.

Confidential Inspection Report

4567 NE 78th Ave.
Portland, OR 97213

Inspection Date: May 11, 2013 10:00 AM.
Client: John Doe
 4321 Easy Street
 Portland, OR 97213
 503-123-4567.
Inspection Site: 5678 SW 78th Ave.
 Portland, OR 97213
House Occupied? Yes.
People Present: Selling agent, Purchasers.

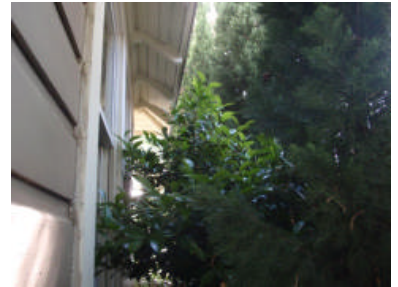
Trees Condition: **Attention Needed** - Some trees and/or shrubs on the site need to be trimmed.

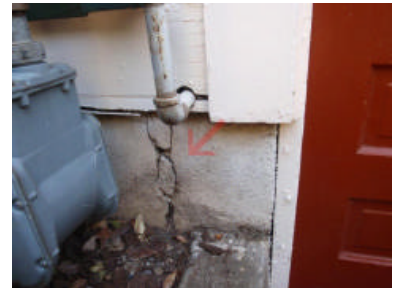
Yes - Cracking in the vertical foundation walls was noted from the exterior. The right side foundation crack should be repaired with hydraulic cement.

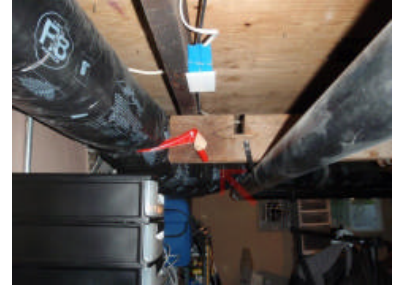
Attention Needed - A support post should be installed under the overhead beam at the rear of the basement.

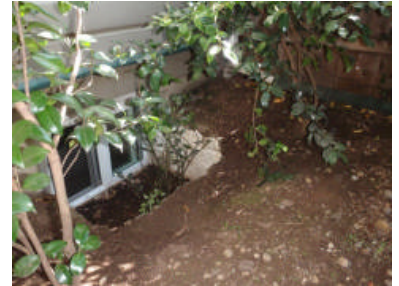
Attention Needed - The ground level in the bottom of the window wells needs to be lowered by digging out the soil to help prevent water from entering the windows or rotting the window framing. Also, the area well needs to be raised to allow for proper grading.

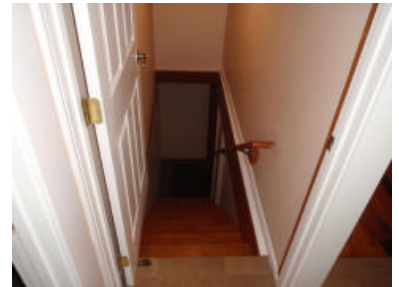
Attention Needed - Safety considerations and/or repairs are needed due to door opening into stairway and handrail not extending to top of stairway.

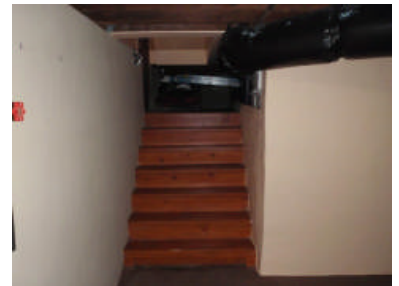
Attention Needed - The staircase from the right exterior does not have a handrail.

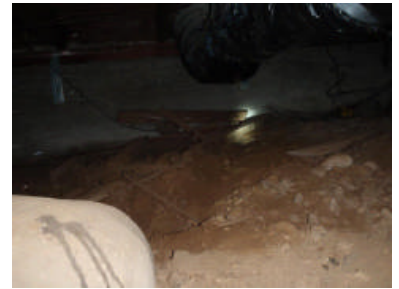
Attention Needed - Exposed soils in a crawlspace should be covered with a retardant material to prevent moisture or standing water from deteriorating wood framing above. Approved materials include: 6 mil. black polyethylene sheeting. Also, remove all wood debris prior to the installation of the vapor barrier.

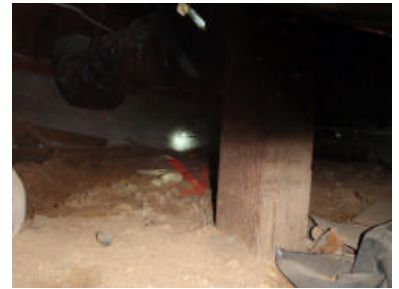
Attention Needed - There is soil to wood contact. This allows a direct path for insects or wood decay and should be eliminated.

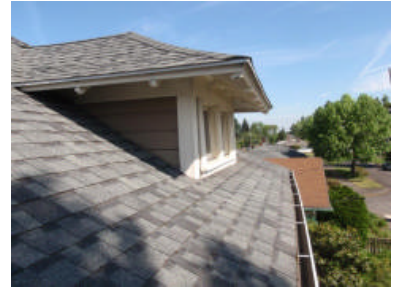
Action Necessary - The flashing where the roof intersects with a dormer walls needs proper installation. Consult a licensed roofing contractor for repairs.

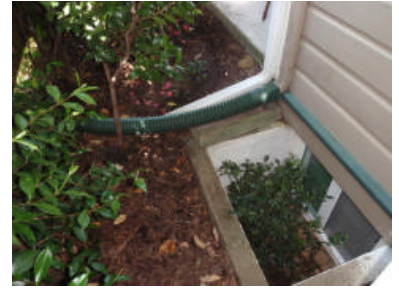
Attention Needed - The down spout drains need adjustment or realignment so that they will carry water away from the foundation.

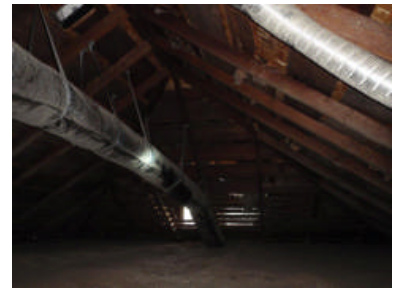
On a high pitched roof, collar ties are used to help distribute the load factor on the exterior walls. This structure does not appear to have adequate collar ties. Further evaluation by a licensed contractor is recommended to determine the need for appropriate installation.

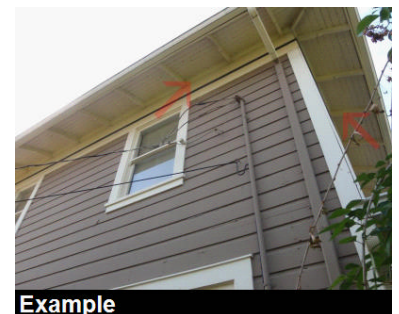
Attention Needed - There are ridge vents installed; however, eave vents are needed for proper intake air in order to perform correctly.

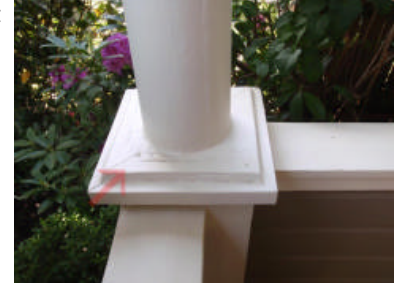
Attention Needed - The trim around the left front support needs some minor repair to prevent further deterioration (replace damaged wood).

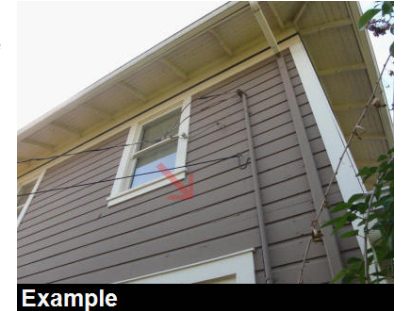
Example

Attention Needed - The exposed painted surfaces need some minor attention or touch-ups to make the surfaces weather tight. These repairs should be scheduled soon to prevent further deterioration.

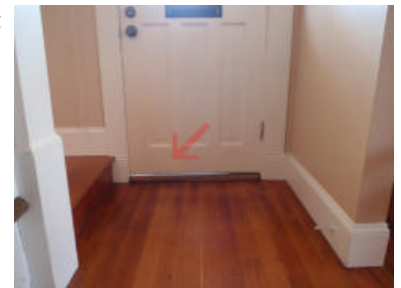
Attention Needed - Weather stripping is needed at the bottom of the front entry door.

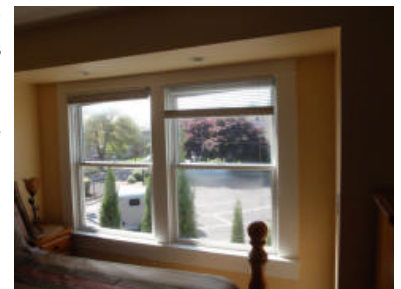
Attention Needed - The south side master bedroom double pane insulated glass windows have lost their vacuum seal. As a result of losing this seal, condensation between the two panes creates a clouded or streaked appearance. The window still performs the task of keeping the weather out, but it has lost much efficiency.

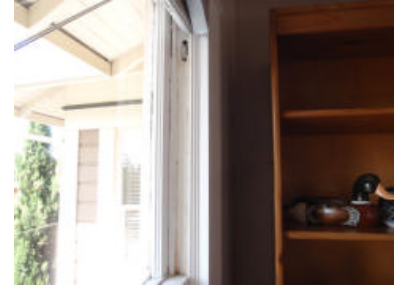
Attention Needed - The counterbalance ropes on a number of windows are broken or missing.

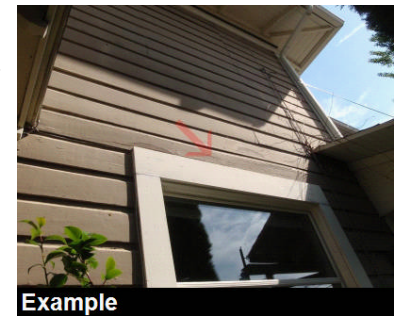
Attention Needed - There is no flashing above the window trim. As a result of this missing flashing, caulk must be maintained to prevent water intrusion.

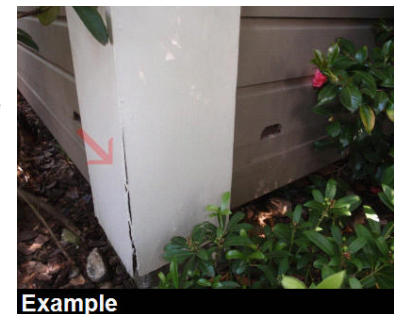
Attention Needed - A few spots around the structure were noted that need to be caulked. Examples - Caulk should be applied to trim around window frames or doors, and piping and service penetrations. Also, any cracks that allow moisture or wind entry should be caulked to prevent deterioration.

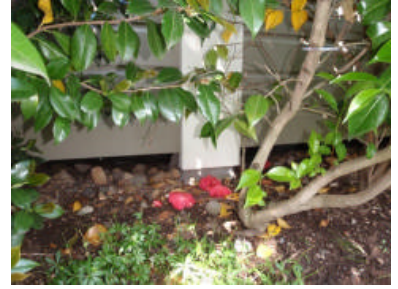
Due to limited visibility under the deck, I was not able to verify the structural condition of the framing members.

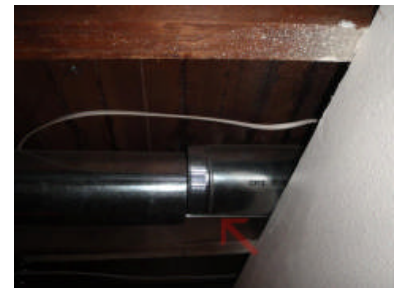
Ducts Condition: **Attention Needed** - The duct has an air leak that reduces the effectiveness of the heating system.

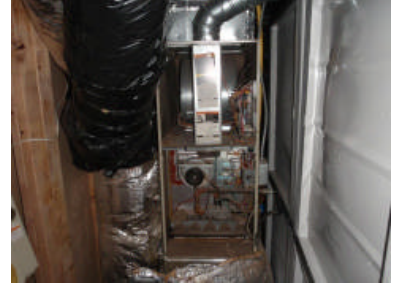
Attention Needed - The furnace needs to be cleaned and serviced at this time to assure safe and efficient operations.

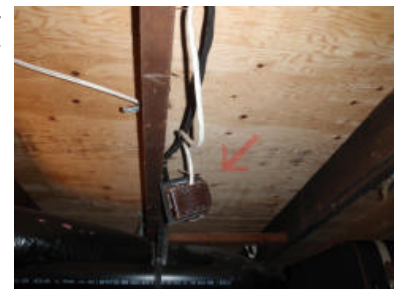
Circuit Wiring Condition: **Attention Needed** - The junction box and wiring for the old basement dryer needs to be properly installed or terminated.

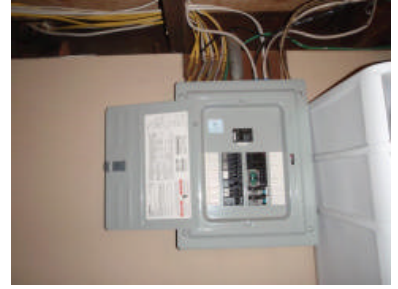
Attention Needed - A final permit sticker was not found on the 100 amp main panel. Consult the city for proper final inspection.

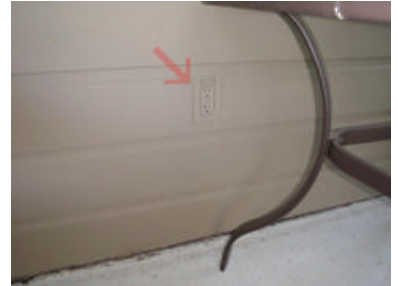
Attention Needed - The weather protected outlet cover plate needs to be replaced. The outlet is Ground Fault Circuit Interrupt protected.

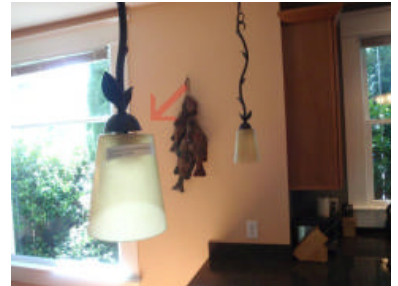
Attention Needed - The one of the light fixtures is damaged (not on fixture states that it will be replaced).

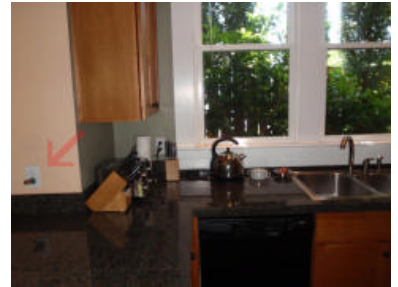
Attention Needed - There is a Ground Fault Circuit Interrupt outlet installed in the area of the sink. However, it failed to stop the current flow to the outlet to the left of the sink. Consult an electrician for repairs.

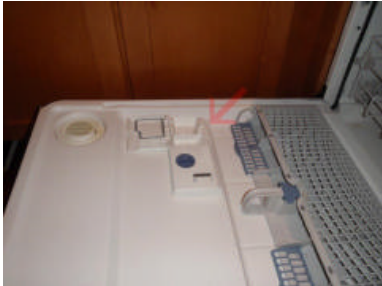
| <i>Dishwasher:</i> | <p>Attention Needed - Through a visual or functional test, it was determined that the dishwasher soap dish was not operational (will not lock due to broken plastic tab).</p> |

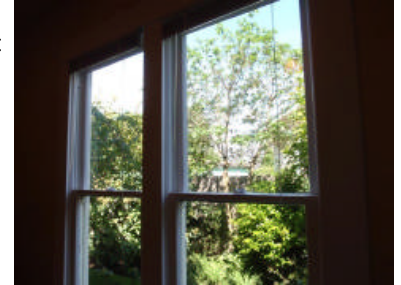
| <i>Windows:</i> | Attention Needed - The windows or associated hardware in the laundry area needs are sealed shut and need repair. |

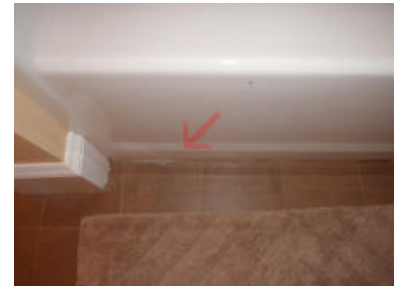
Attention Needed - The caulking in the water contact areas appears to need attention. Damage may result if not corrected.

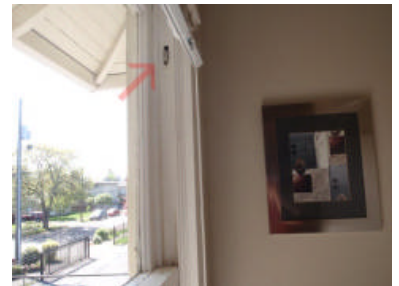
Attention Needed - Both of the counterbalance ropes on the noted windows are missing. For safety reasons, these should be replaced.

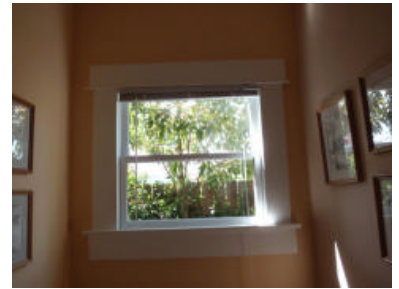
Attention Needed - The window is painted or sealed shut; however, it is newer and appears to in satisfactory condition.
